PROPERTY
INSPECTORS.ME

PROPERTY INSPECTION REPORT CARD

SUMMARY

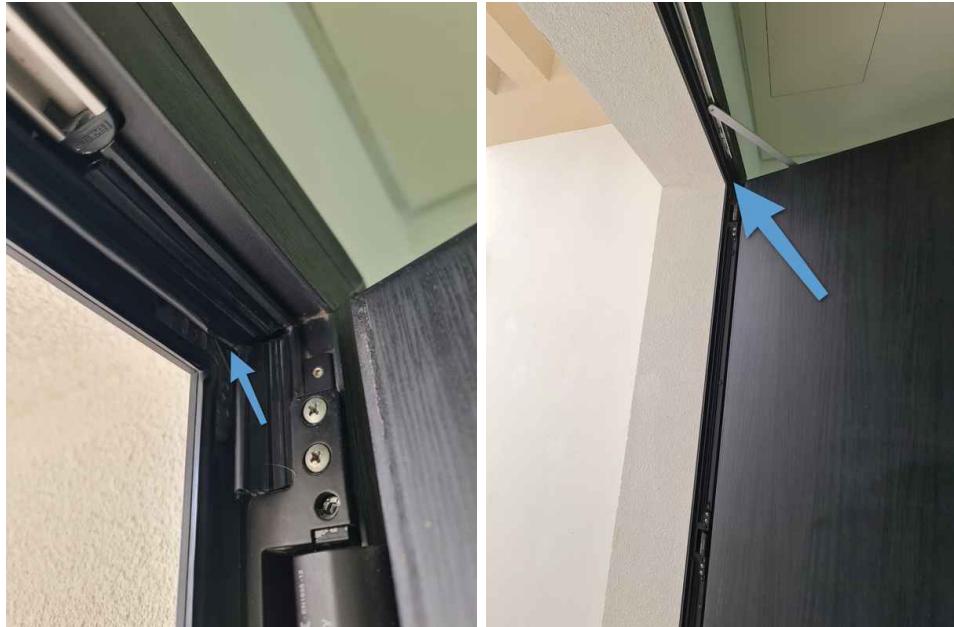
2.2.1 Doors

DAMAGED WEATHER-STRIPPING

At the time of the inspection, weather-stripping at doors was generally damaged or deteriorated.

Contact a qualified handyman.

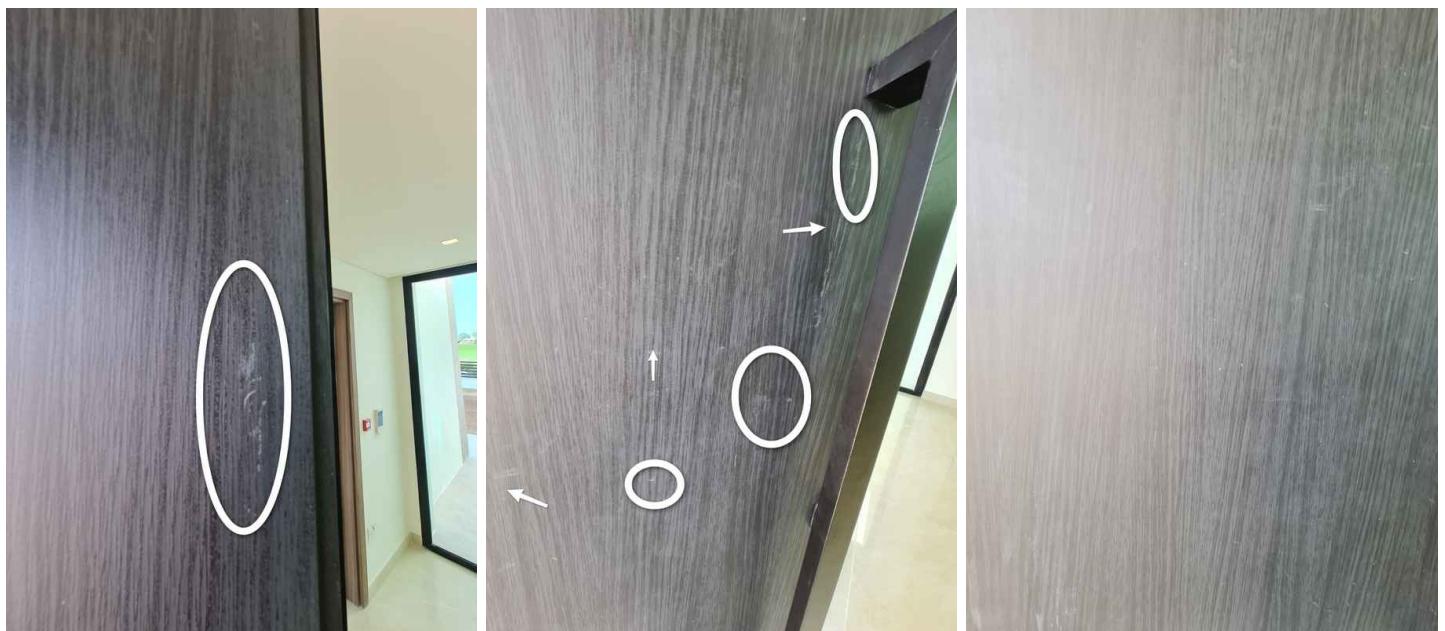
2.2.2 Doors

MINOR SCRATCHES AND IMPACT DAMAGE

The door was seen to have instances of impact damage and scratches. This should be redecorated. Fresh paint coat recommended.

Contact a qualified carpenter.

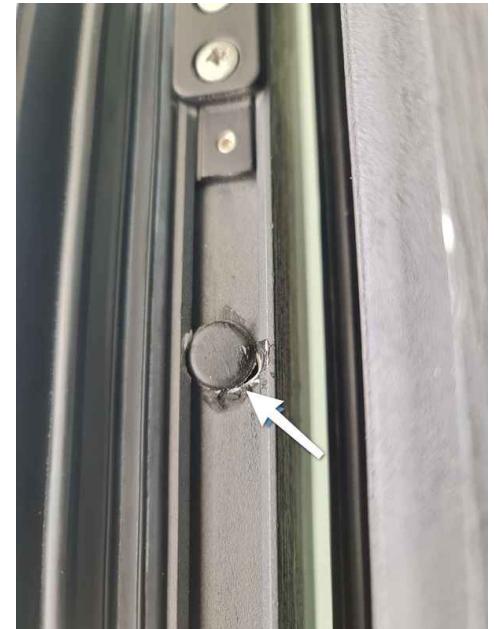
2.2.3 Doors

**DAMAGED COMPONENT**

A door component was seen to be damaged.

Contact a qualified professional.

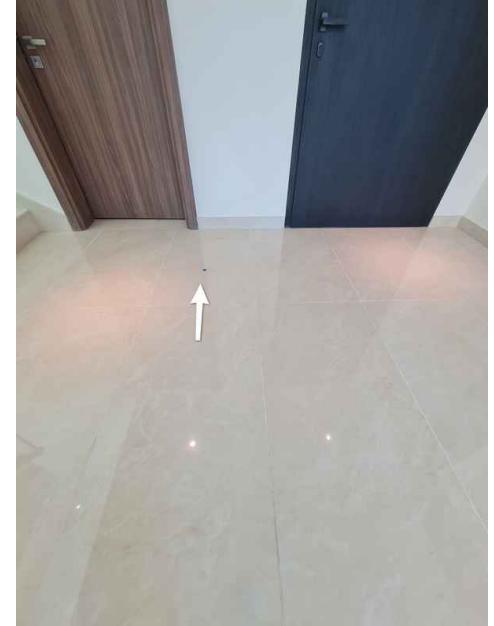
2.3.1 Floors

Hollow tile

Contact a qualified flooring contractor

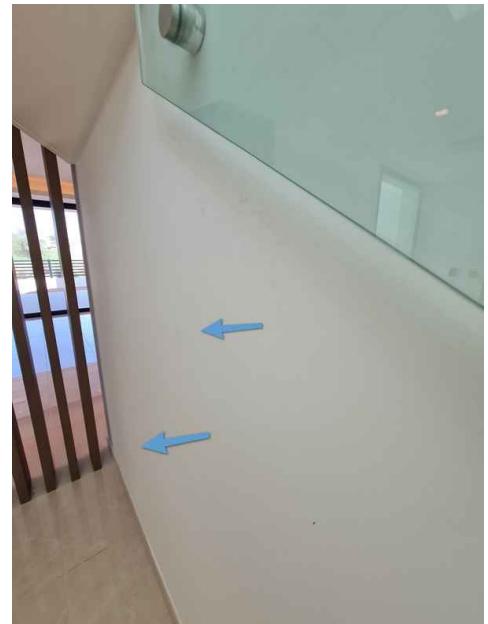
2.4.1 Walls

Sub-standard patching observed at time of inspection.

Contact a qualified drywall contractor.

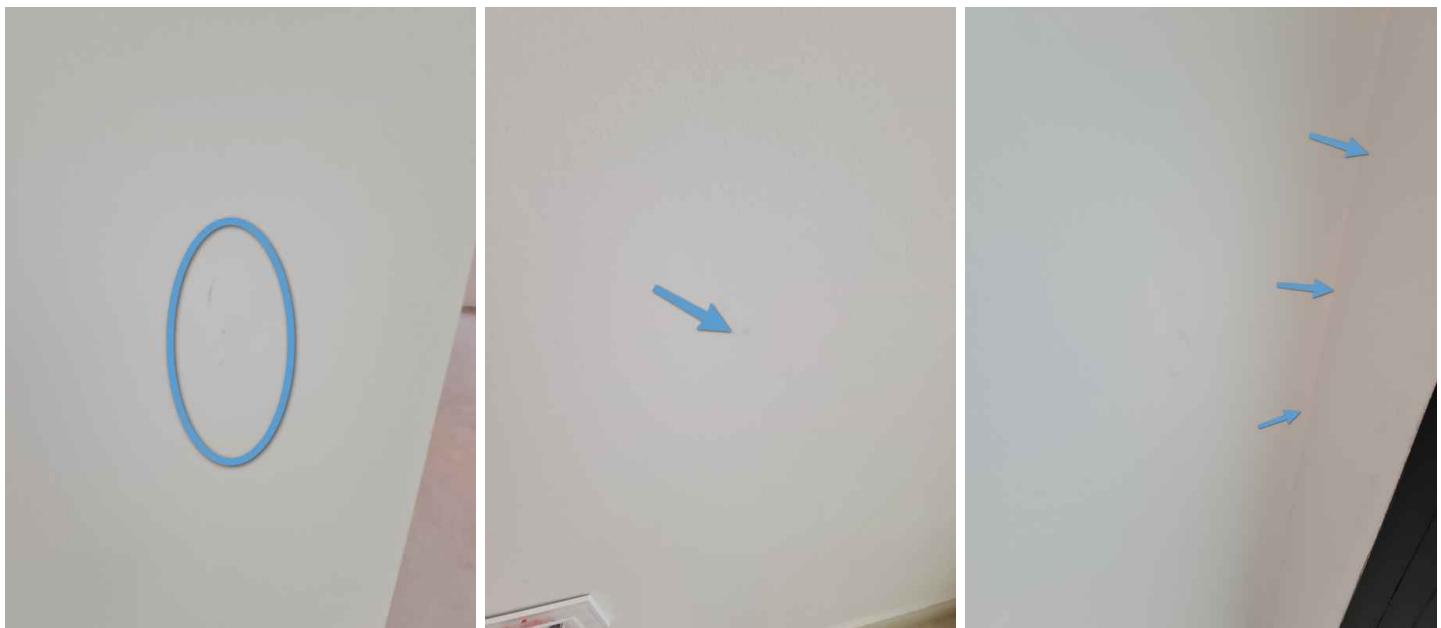
2.4.2 Walls

The painting was observed to have poor finishing and inadequate detailing.

Contact a qualified painting contractor.

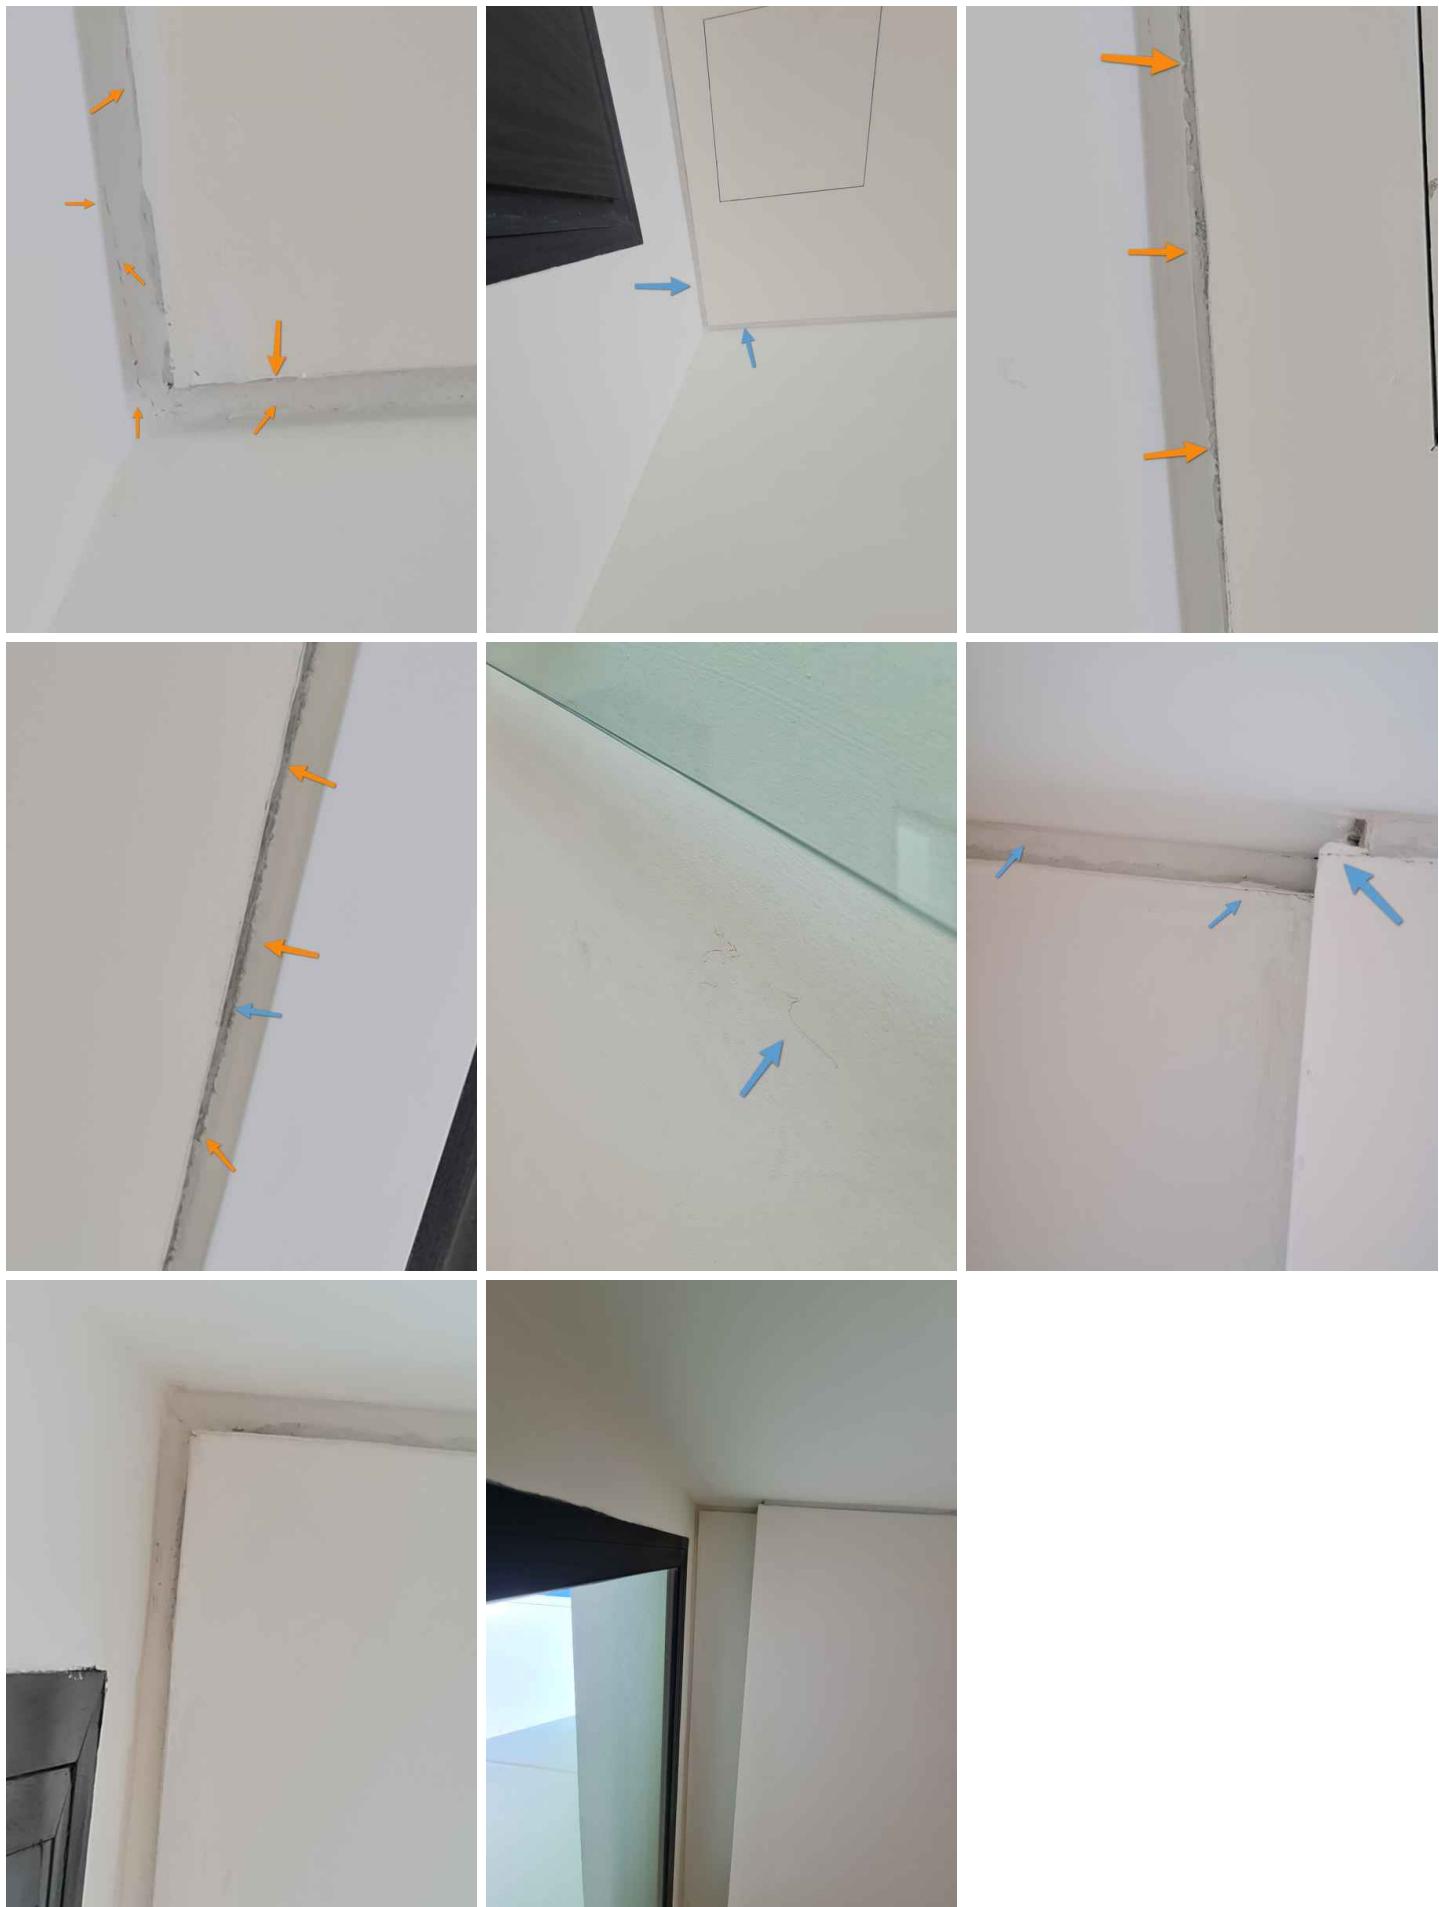
HAIRLINE CRACKS

The ceiling was discovered to have several small hairline cracks.

Contact a qualified painting contractor.

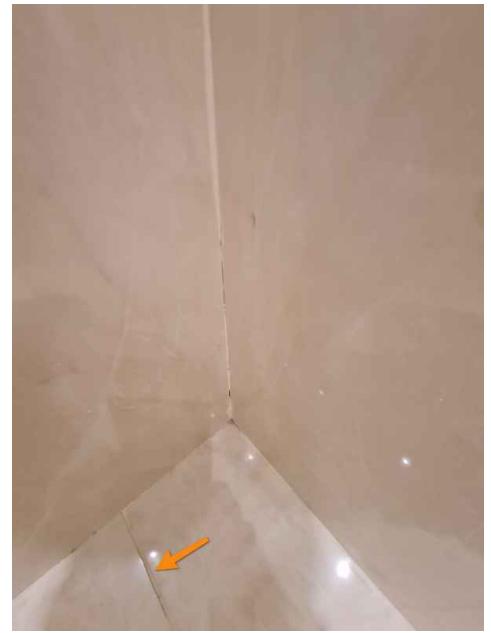
3.3.1 Floors

Need levelling

Contact a qualified flooring contractor

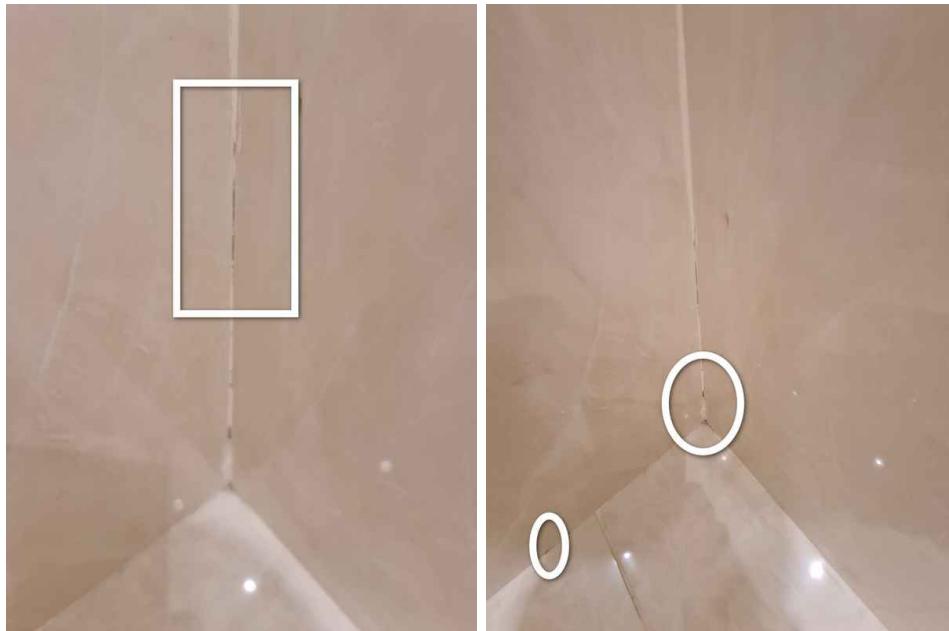
3.4.1 Walls

**MINOR CORNER CRACKS**

Minor cracks at the corners of walls.

Contact a qualified professional.

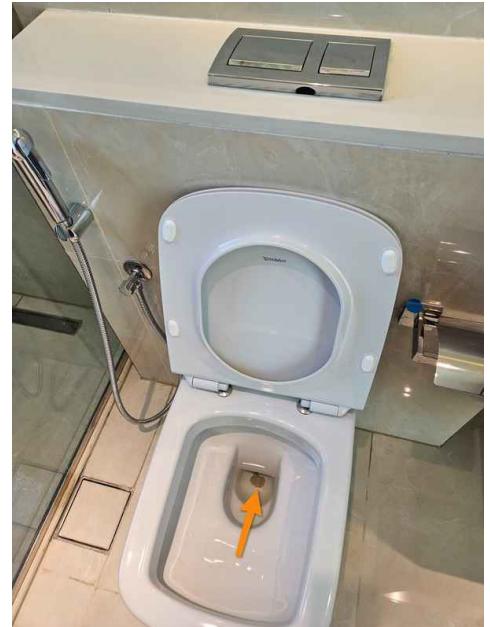
PREMATURE DEGRADATION OF SANITARY FIXTURE

WC was discovered to be deteriorating earlier than expected.

Damage

Contact a qualified professional.

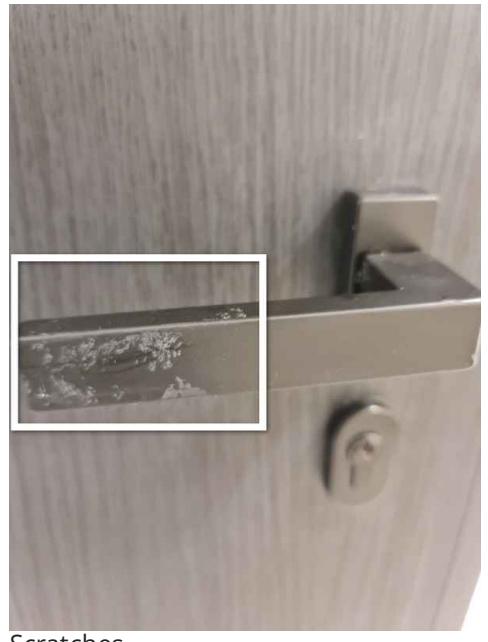
MINOR SCRATCHES AND IMPACT DAMAGE

Scratches

Contact a qualified carpenter.

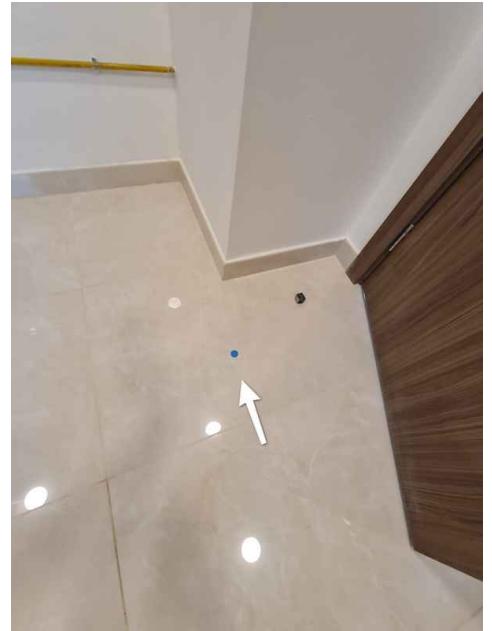
Hollow tile found.

Hollow tile

Contact a qualified flooring contractor

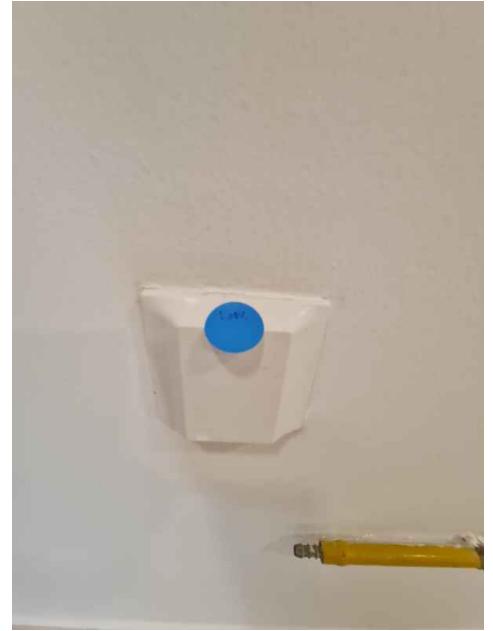
COVER PLATES DAMAGED

Damaged cover plate.

Damaged

Contact a qualified electrical contractor.

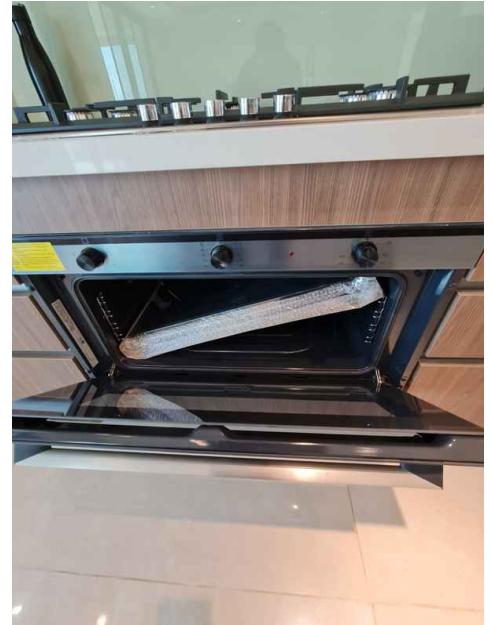
Slight particles of smoke dust & smell was observed in the oven.

Recommend to show to professional to check the oven/ white goods for it's functioning.

Contact a qualified professional.

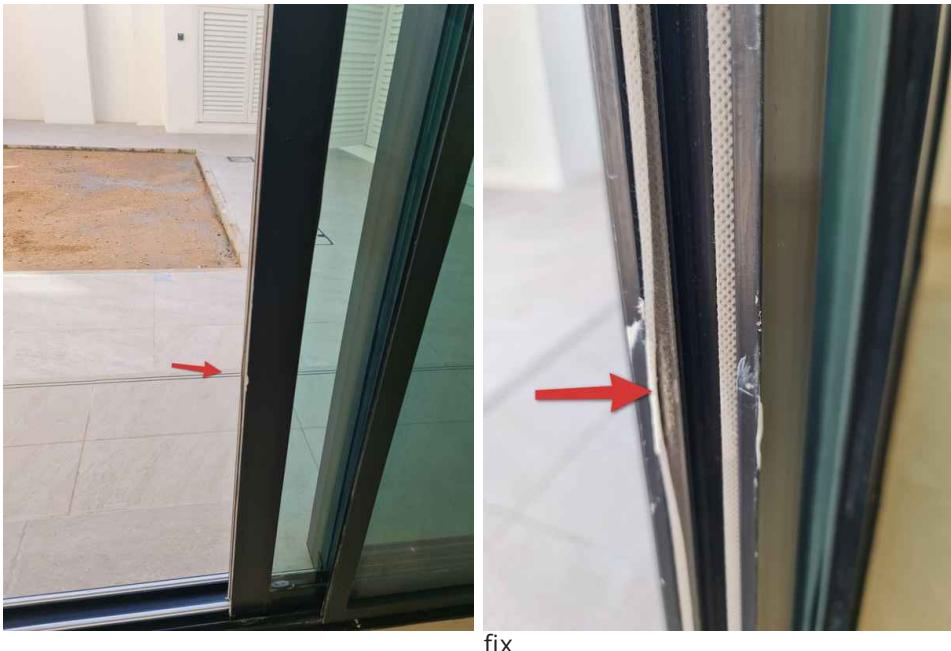
The sliding doors rubber seal was discovered to be poorly installed with sections that had come loose.

Contact a qualified window repair/installation contractor.

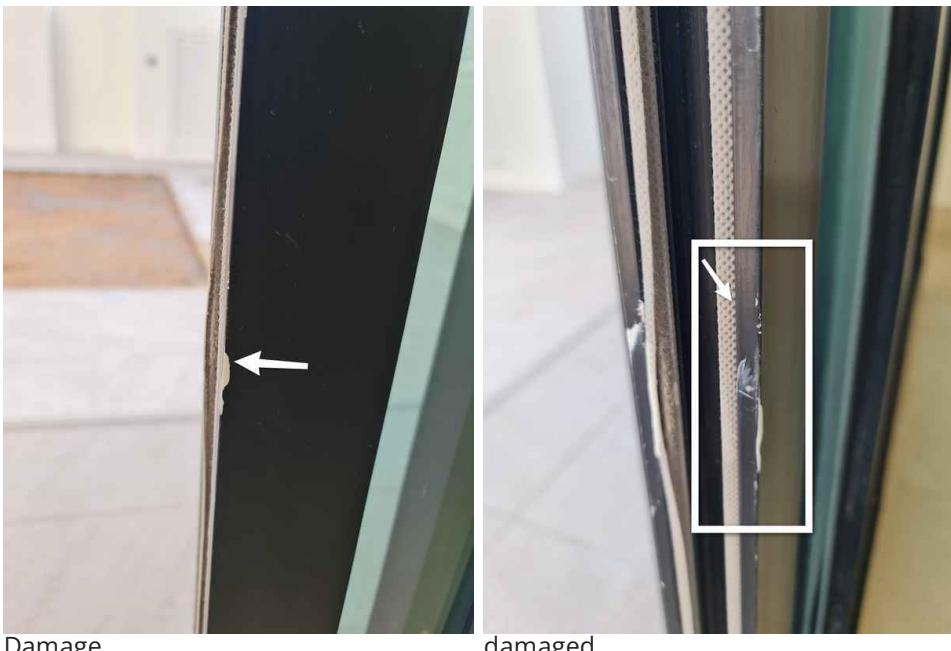
7.7.2 Sliding Glass Doors

SLIDING DOORS FRAME SCRATCHES AND IMPACT DAMAGES

The sliding glass doors frame was discovered to have occurrences of slight scratches and impact damages.

Contact a qualified window repair/installation contractor.

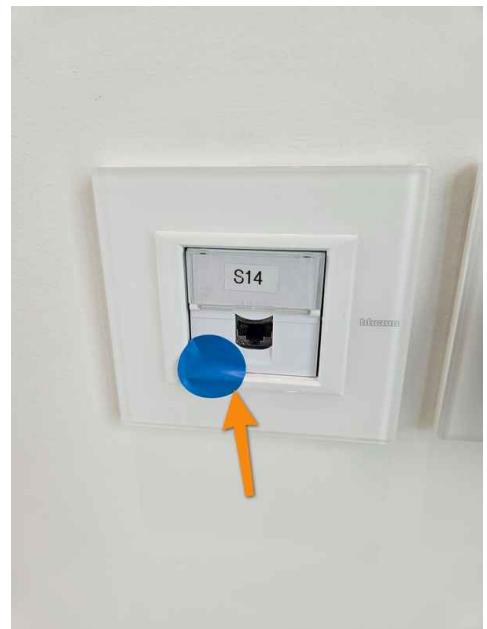
7.9.1 Electrical

COVER PLATES DAMAGED

One receptacle have a damaged cover plate. Replacement of the unit is recommended.

Damaged

Contact a qualified electrical contractor.

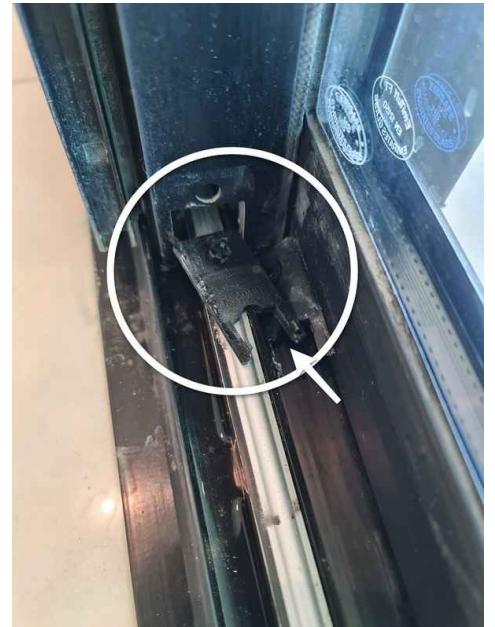
DAMAGED

Sliding glass door channel track appears to have general damage, but are operational. Recommending a window professional clean, lubricate & adjust as necessary.

Channel track damage

Contact a qualified window repair/installation contractor.

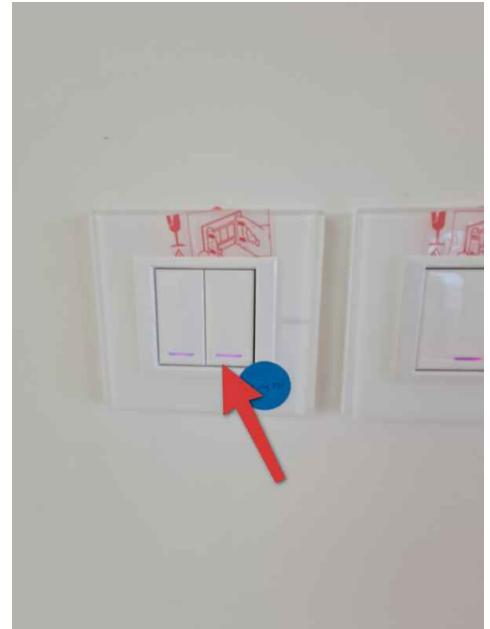
An electrical switch was noted to possess a sunken button and needs to be substituted with a new one. It is not working for the assigned functionality.

Not working

Contact a qualified professional.

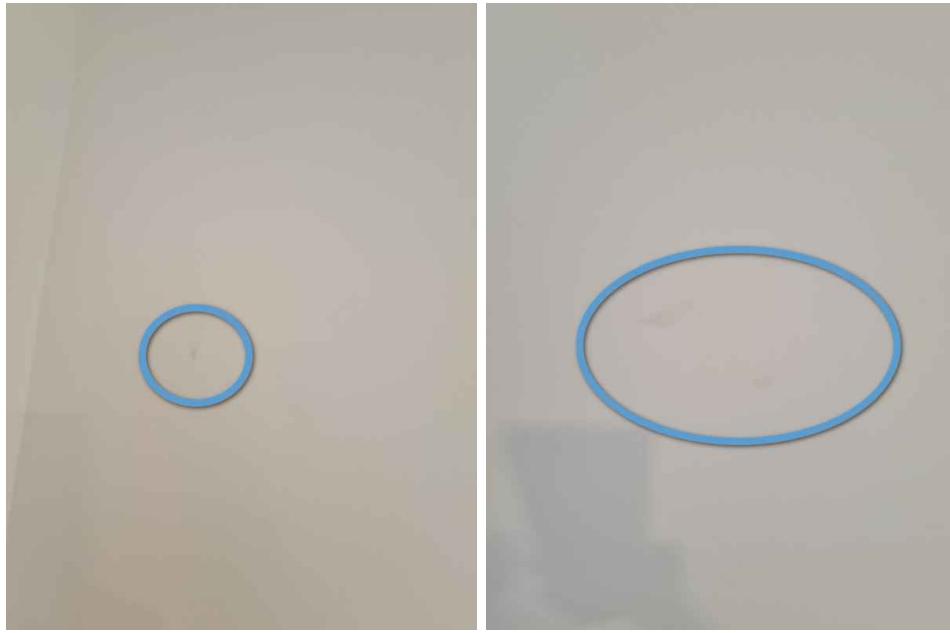
9.4.1 Walls

The painting was observed to have paint stains and inadequate detailing.

Contact a qualified painting contractor.

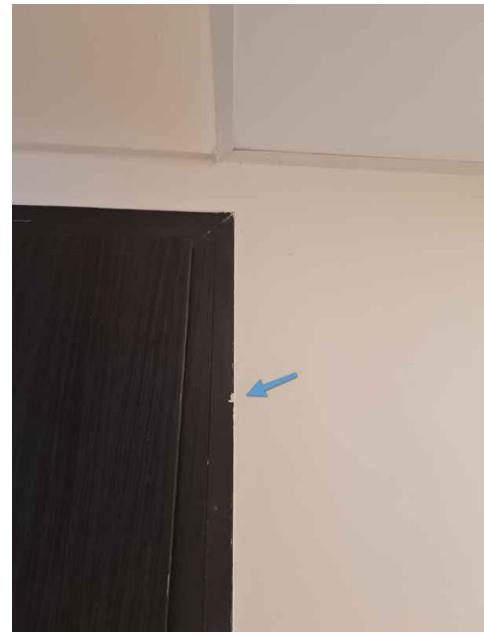
The painting was observed to have flaws due to substandard craftsmanship, featuring excess paint stains and inadequate detailing.

Contact a qualified painting contractor.

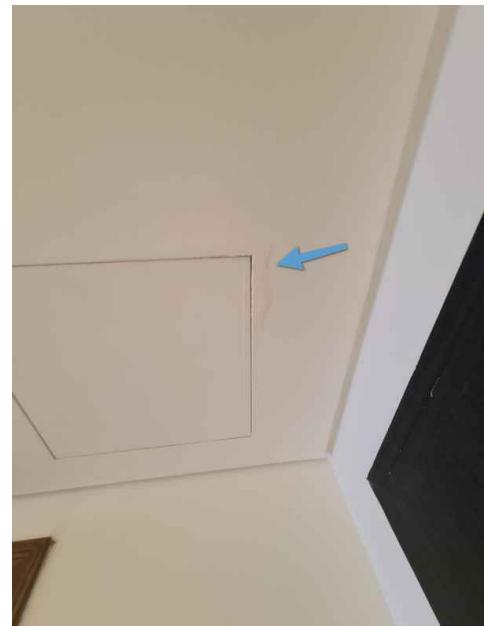
STAIN(S) ON CEILING

There is a stain on ceiling/wall that requires paint.

Stain

Contact a qualified professional.

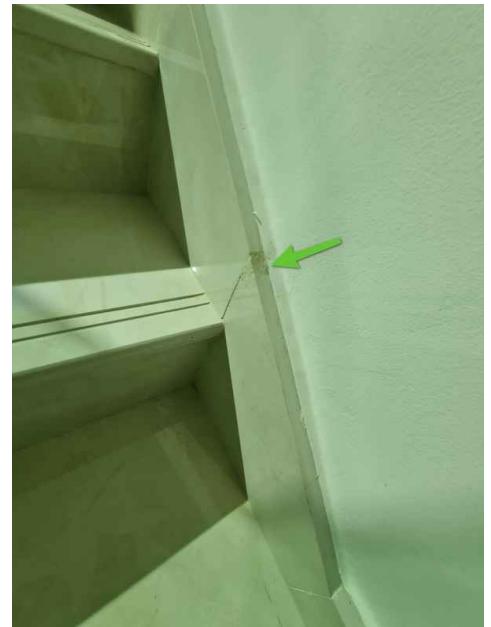
MODERATE WEAR

Floors in the home exhibited moderate surface wear along major paths of travel.

Contact a qualified flooring contractor

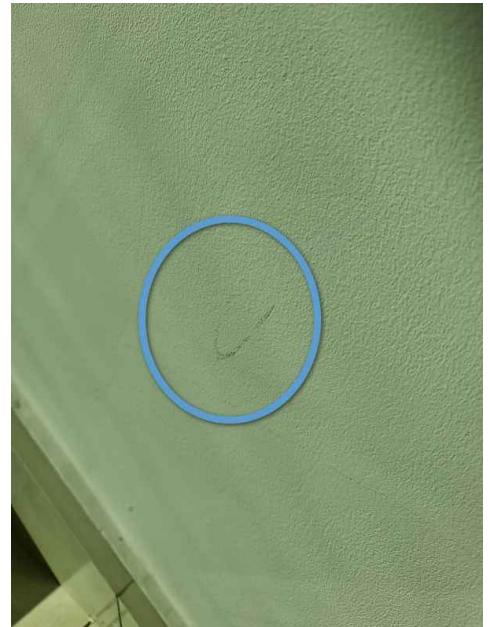
The painting was observed to have flaws due to excess paint stains

Contact a qualified painting contractor.

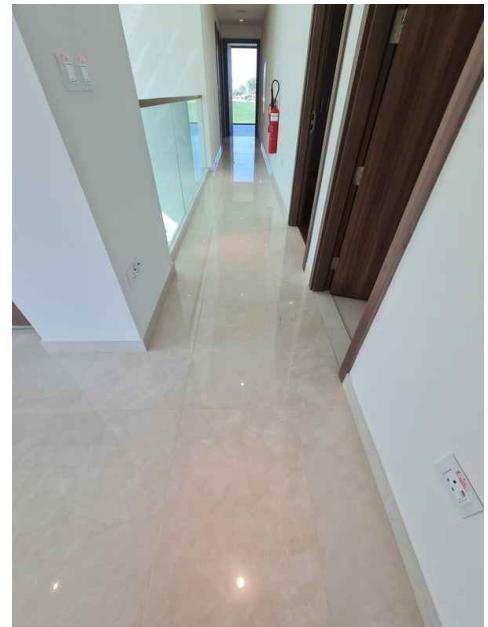
14.3.1 Floors

The floor tile grouts at joints were noted to have color shade difference at grouts. Need to regROUT.

Contact a qualified flooring contractor

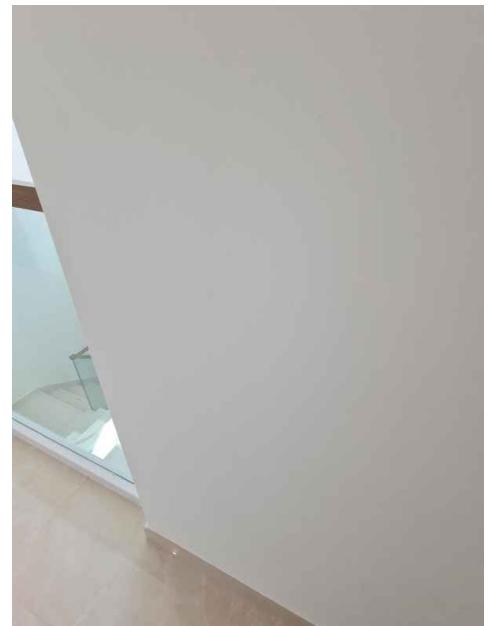
14.4.1 Walls

POOR PAINT FINISHES

The painting was observed to have paint stains

Contact a qualified painting contractor.

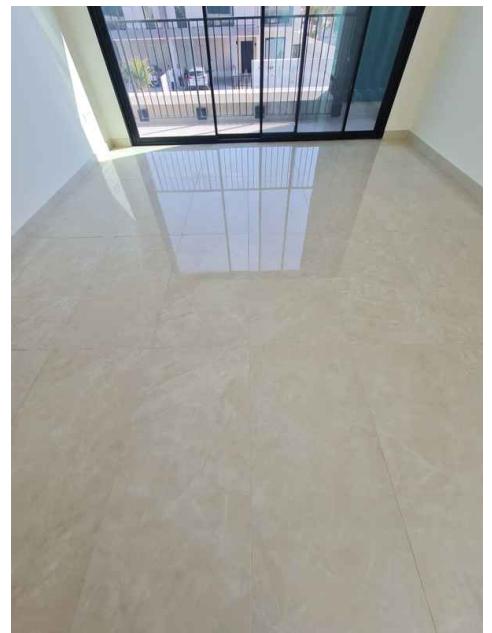
The floor tiles grouting were noted to have color shade difference.

Contact a qualified flooring contractor

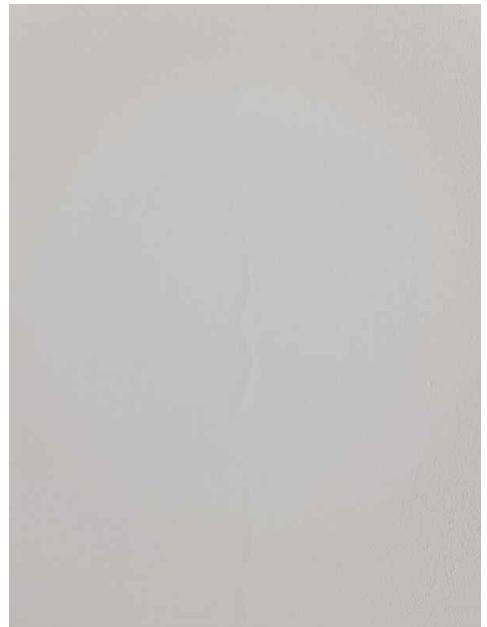
15.4.1 Walls

POOR PAINT FINISHES

Contact a qualified painting contractor.

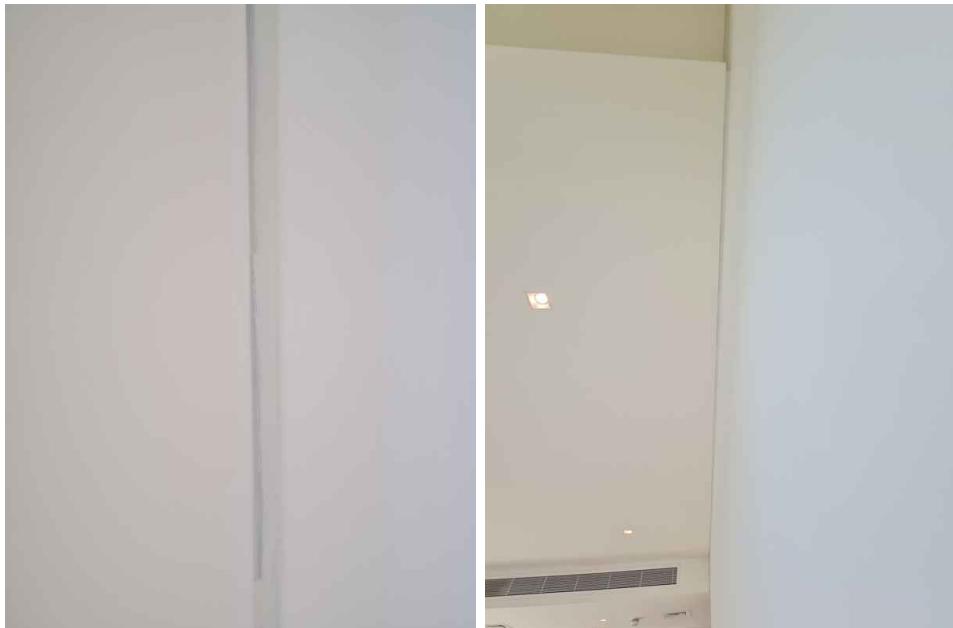
15.5.1 Ceilings

poor finishing

Contact a qualified professional.

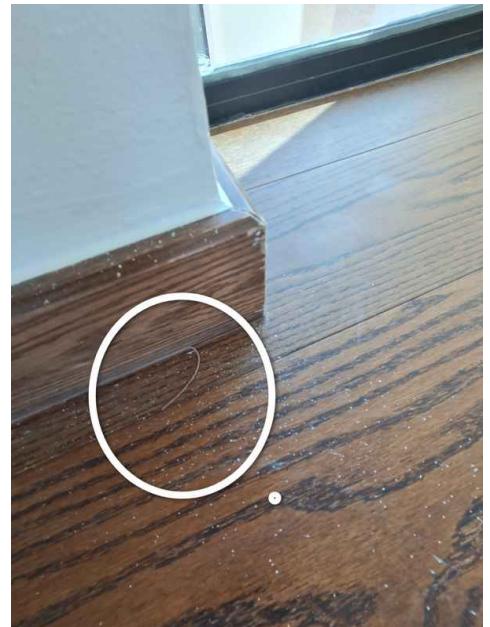
16.3.1 Floors

MODERATE WEAR

Contact a qualified flooring contractor

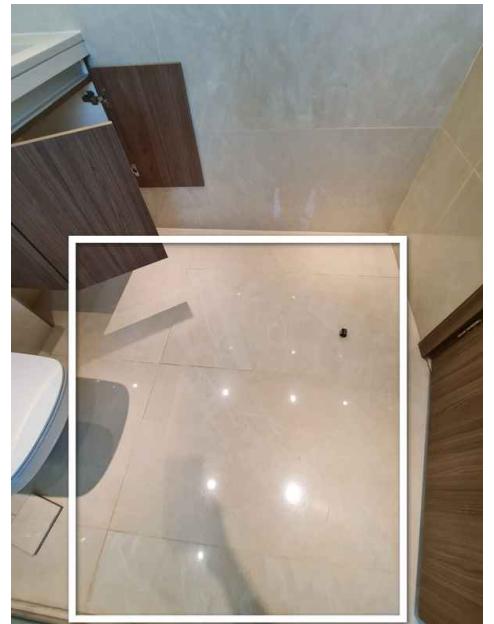
19.3.1 Floors

Regrout

Contact a qualified flooring contractor

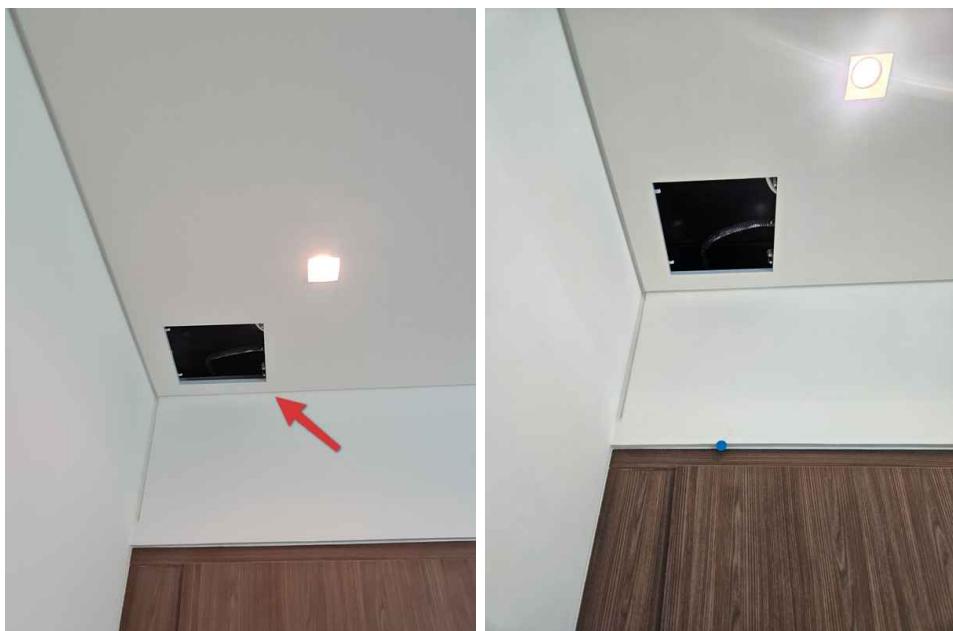
20.5.1 Ceilings

Critical

Fix access hatch

Contact a qualified carpenter.

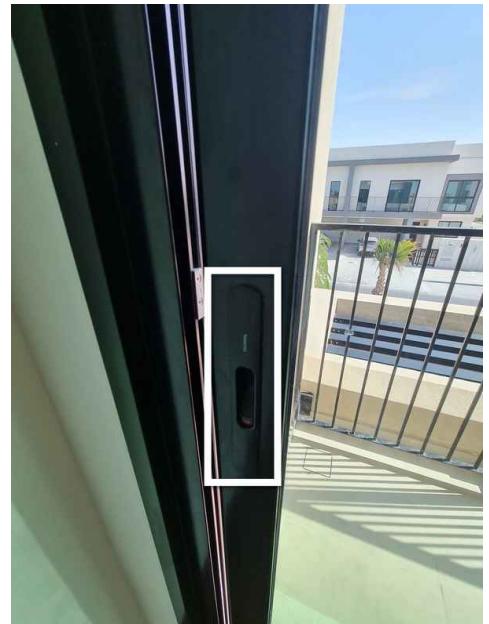
21.7.1 Sliding Doors

DEFECTIVE LOCKING MECHANISM

Door lock faulty

Contact a qualified window repair/installation contractor.

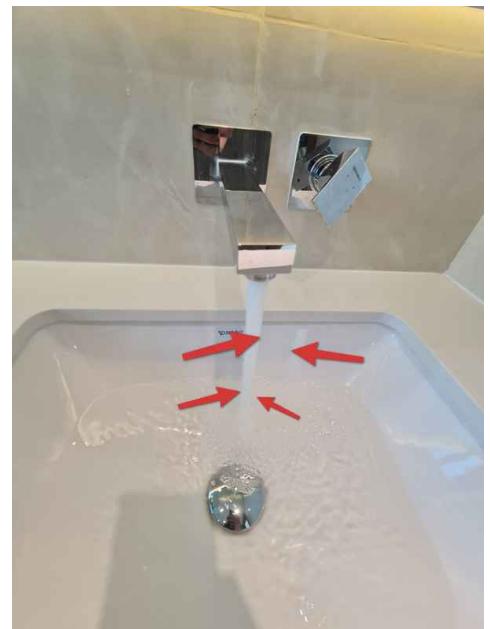
22.11.1 Plumbing internal

LOW WATER PRESSURE

Contact a qualified professional.
